Inspection Report Minerals Regulatory Program March 9, 2010

| Mine Name: Lisbon Valley | Permit Number: M/037/0088 |
| Operator Name: Lisbon Valley Co LLC | Inspection Date: October 7, 2009 |

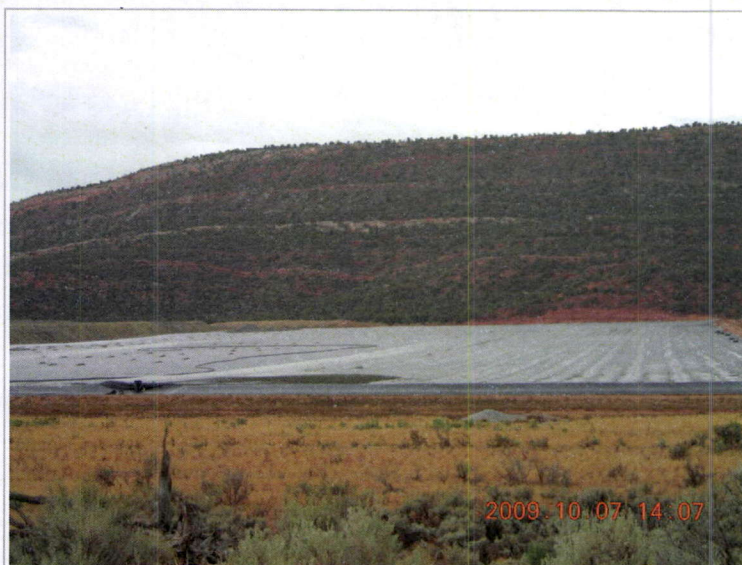
Heap Liner

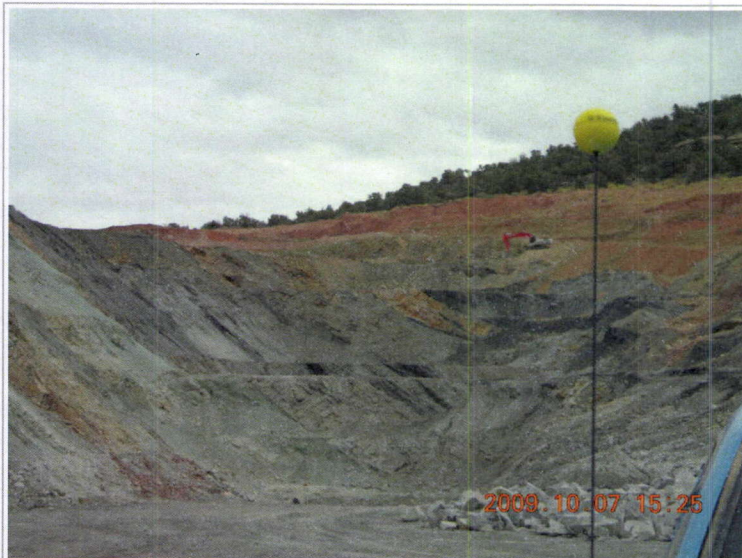
Centennial pit, track hoe working on upper lift

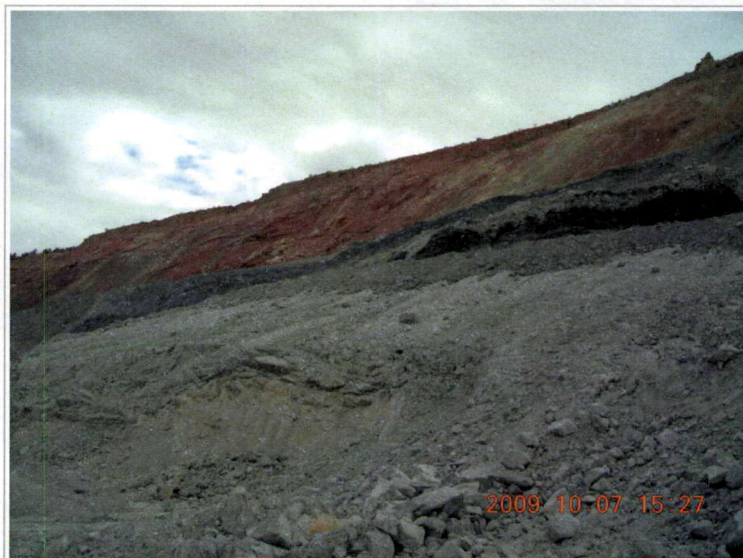
Slide area
